STRESS CORROSION OF CHAPARRAL FIN RETAINERS

John H. Honeycutt

Army Missile Command Redstone Arsenal, Alabama

25 January 1974

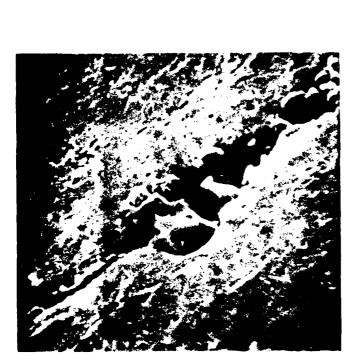
After receiving the specimens, a metallurgical examination was conducted on the 17-7PH specimens. Inclusions and cracks were noted in the failed and unfailed specimens. These inclusions were caused by a titanium impurity, probably introduced during the alloying process (Figures 1-3). The titanium carbide inclusions develop stress risers, which are detrimental to the life of the retainer, especially when they emerge at the retainer surface and come in contact with a corrosive media such as a marine environment.

Figure 3. Titanium carbide inclusion, 2000X. (scanning electron microscope micrograph)

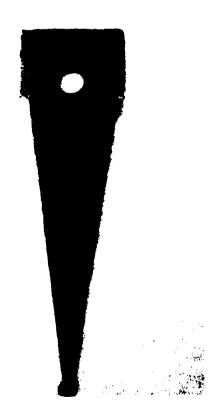
Figures 10 and 11 show a typical specimen failure for this group. All of the specimens exhibited blistering of the dry film lubricant. The first evidence of blistering was G_2 -1-4 after 144 hours of testing. After 312 hours, all specimens showed blistering of the dry film lubricant. See Figure 12.

Figure 11. Typical failure.

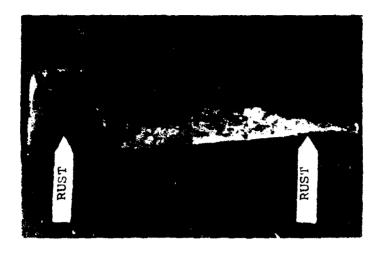
There was some red rust on each of the QQ-S-777 specimens around the countersunk area and also around the edges of the specimens. See Figure 15.

Figure 15. Typical rust on QQ-S-777 specimen.

As a result of test data, it is recommended that the CHAPARRAL fin retainer be fabricated from QQ-S-777 steel.
